Abstract Restoration Of Archaeologist Islamic Castles ''Chosen Models ''

Fuad A. Al- Tarawneh

Mu'tah University, 2008

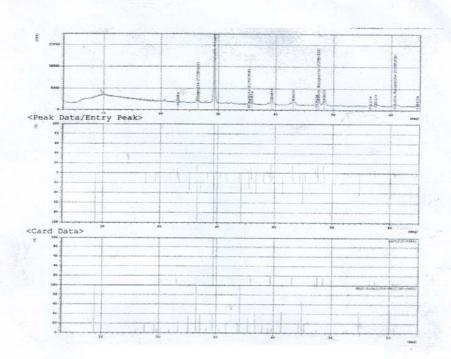
قلعة الشوبك : نموذج تحليل عينة حجارة .

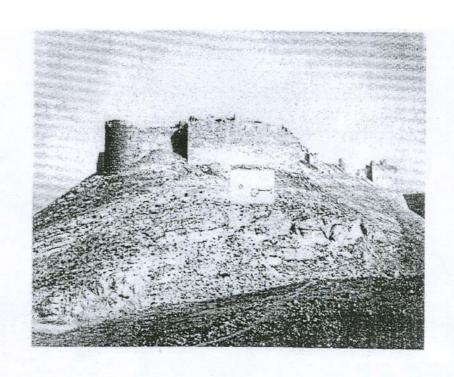
منظر عام لقلعة الشوبك قبل أعمال الترميم " الجهة الشمالية الغربية "

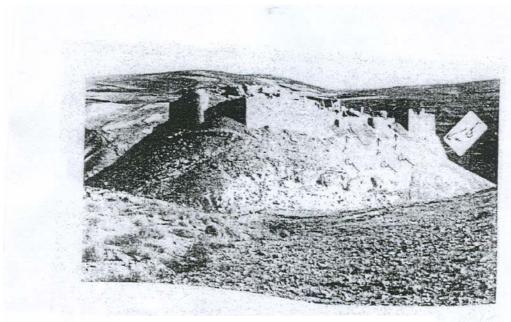
منظر عام لقلعة الشوبك وتبدو بعض أعمال الترميم " الواجهة الغربية "

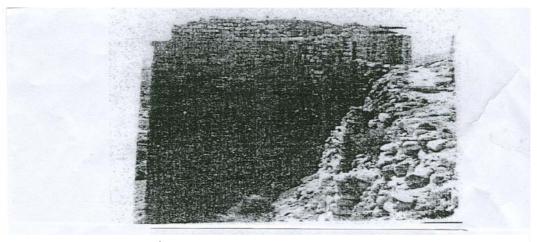
قلعة الشوبك الواجهة الشمالية للبرج الأول " بعض أعمال الترميم "

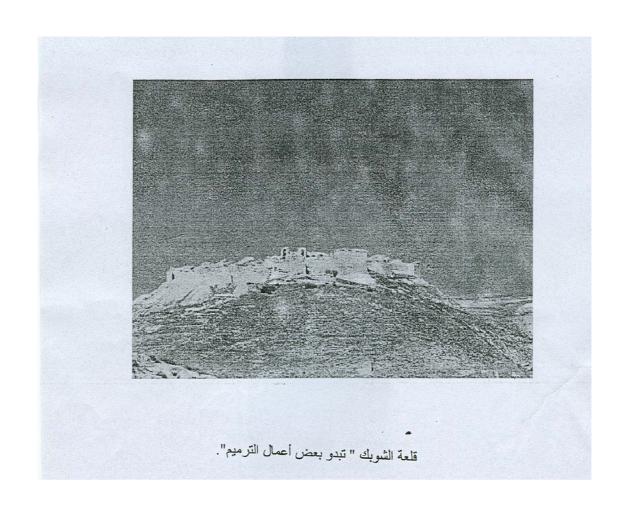
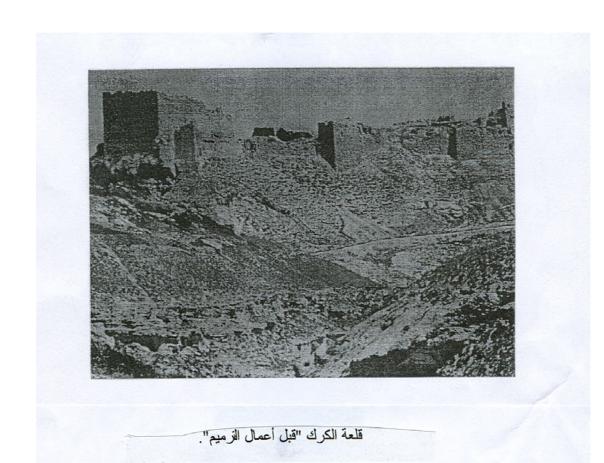
قلعة الشوبك, الجدار الواصل بين البرجين الرابع و الخامس. " و بعض أعمال الترميم"

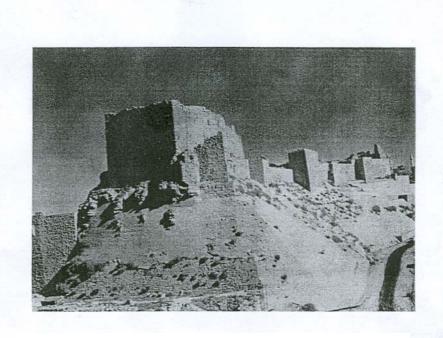
منظر عام قلعة الكرك " و ظهور بعض أعمال الوميم ".

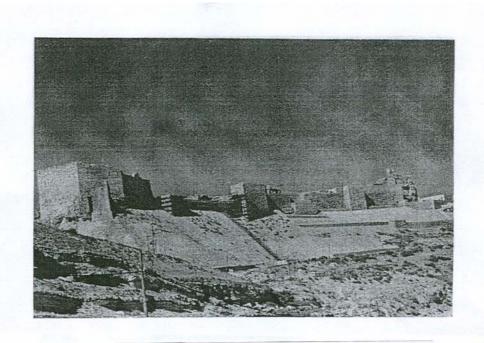
منظر عام قلعة الكرك " بعض أعمال الوّميم بشكل كبير ".

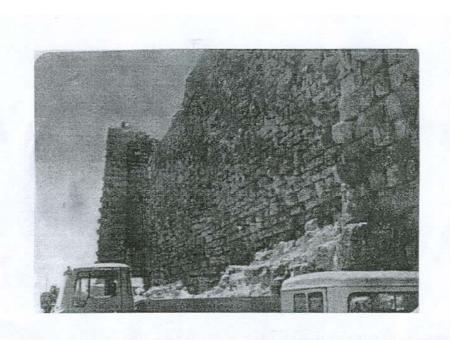
منظر عام قلعة الكرك تصدعات و انهيارات قبل أعمال الترميم.

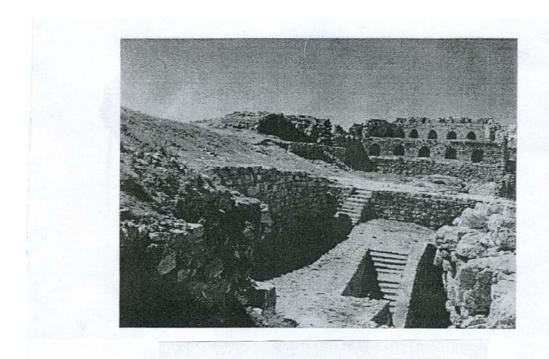
منظر عام قلعة الكرك من الداخل " قبل أعمال الترميم "

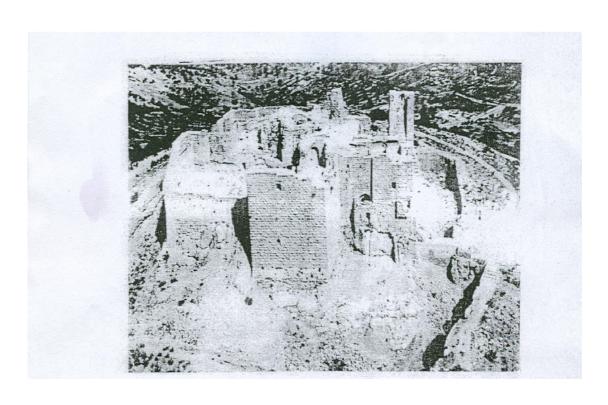
قلعة عجلون منظر عام " تبدو فيه أجزاء مرممة وأجزاء لم تشغلها أعمال الترميم "

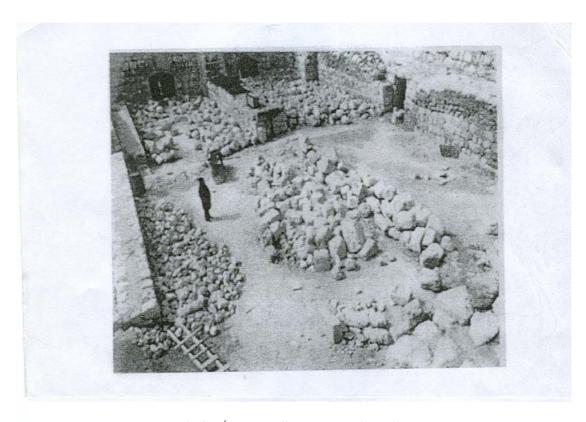
فلعة عجلون منظر عام التجهيزات لأعمال الترميم

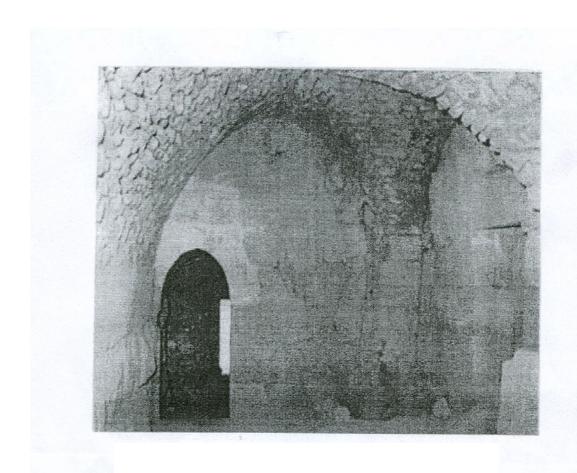
قلعة عجلون " الأقبية التي شملتها أعمال الترميم ".

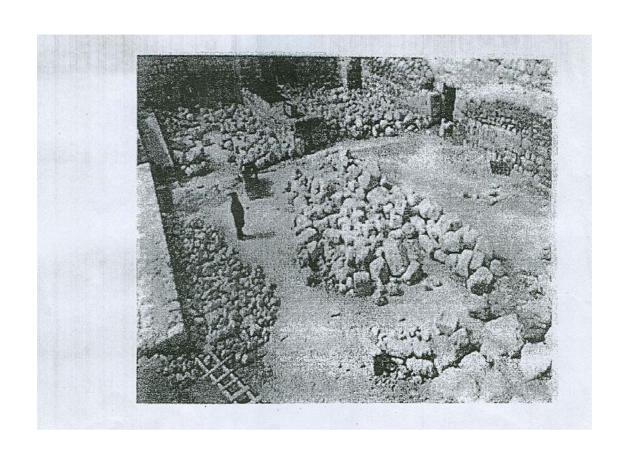
قلعة عجلون منظر عام للتجهيزات لأعمال الترميم
